STATIbar

Crack stitch - general

Sb1

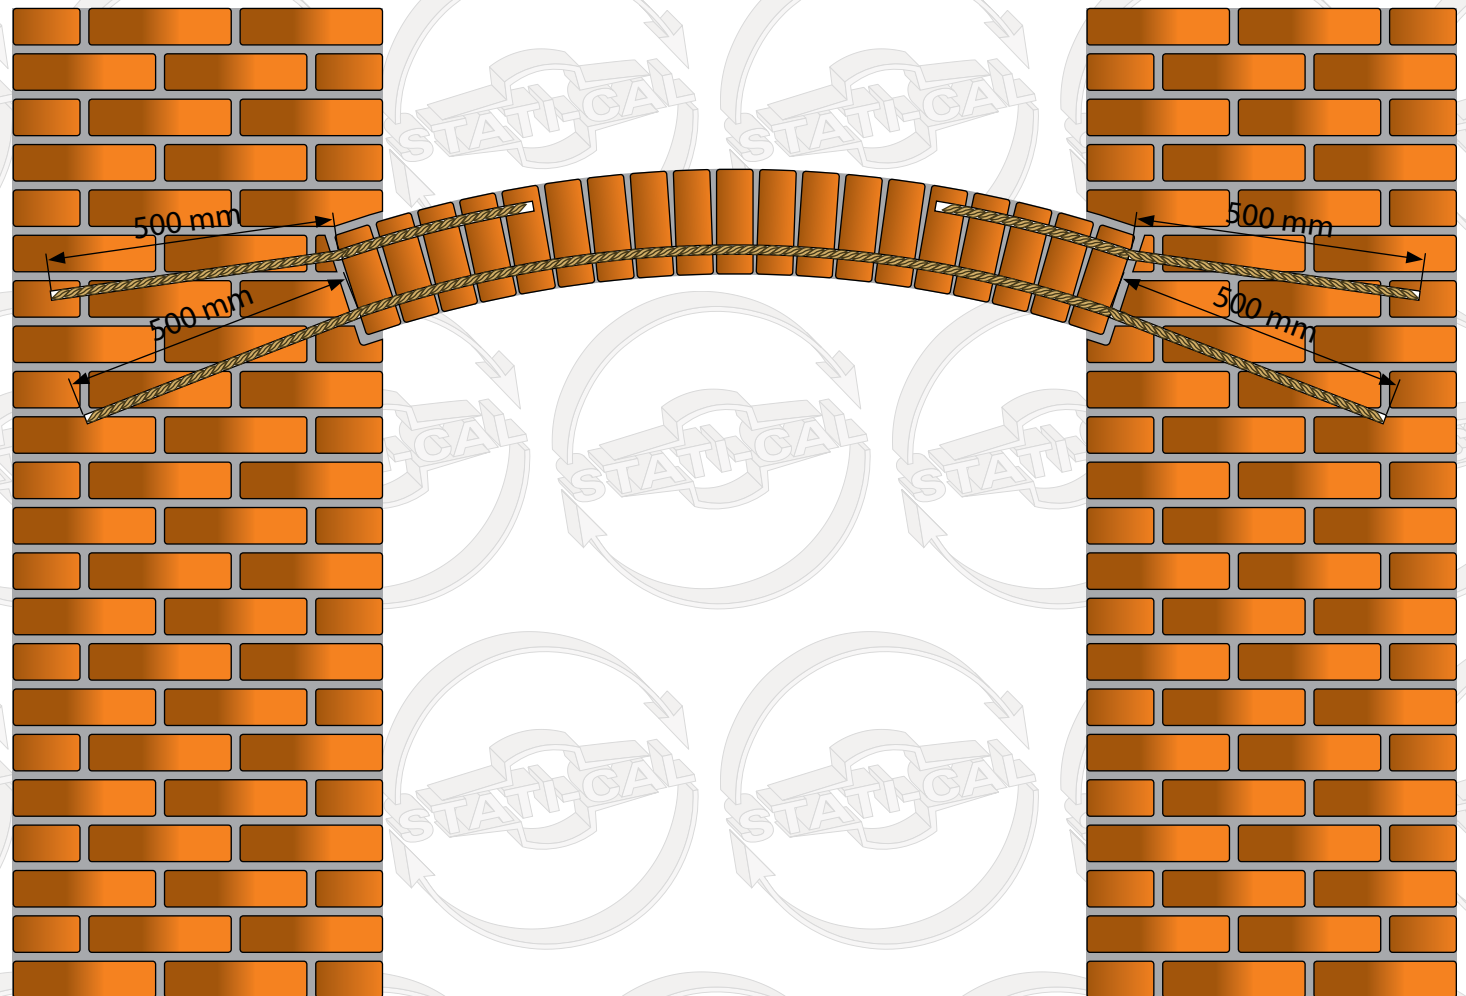
Repair of brick arch
